Home Report

Property: 49

Ross Avenue

Perth

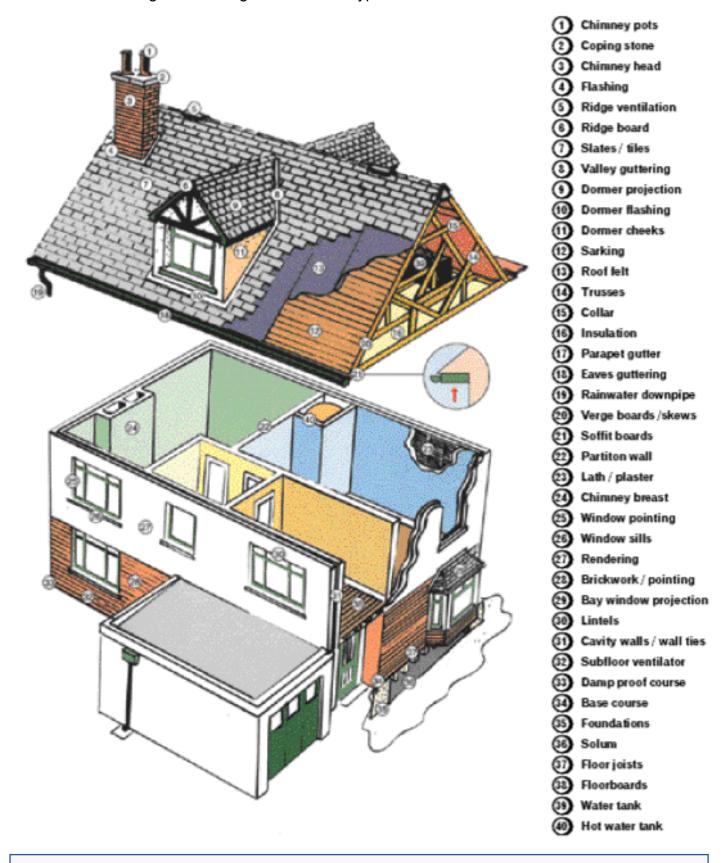
Sectional diagram showing elements of a typical house:

Reference may be made in this report to some or all of the above component parts of the property. This diagram may assist you in locating and understanding these terms.
