61 Castleview, Dundonald, Kilmarnock, Ayrshire, KA2 9JA

Home Report

Single Survey

Property Address	61 Castleview, Dundonald, Kilmarnock, Ayrshire, KA2 9JA
Reference	1054053
Customer Name	Mr & Mrs Gibson
Date of Inspection	8th May 2025
Surveyor's name, qualifications and office	Mark Rutherford MA (Hons) MRICS DM Hall LLP Chartered Surveyors 15 Miller Road Ayr KA7 2AX Tel: 01292 286974 email: ayrresidential@dmhall.co.uk
Prepared By	DM Hall LLP

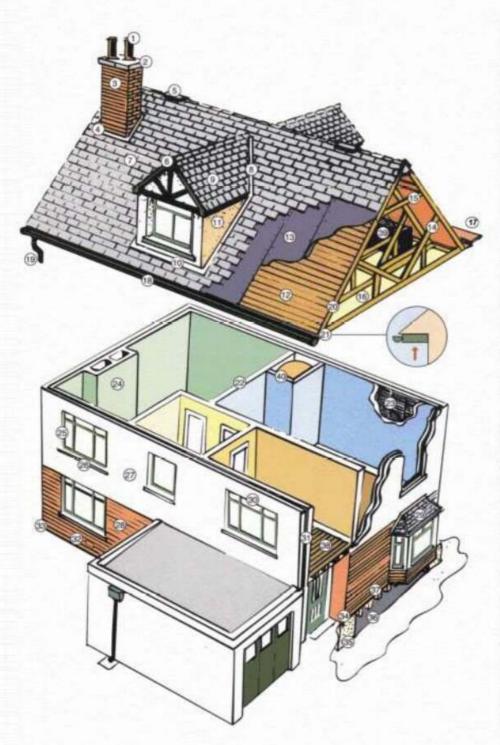
Sectional Diagram showing elements of a typical house

Reference may be made in this report to some or all of the above component parts of the property. This diagram may assist you in locating and understanding these items.

- 1) Chimney pots
- (2) Coping stone
- 3) Chimney head
- (4) Flashing
- (5) Ridge ventilation
- 6) Ridge board
- (7) Slates / tiles
- (8) Valley guttering
- 9 Dormer projection
- 10 Dormer flashing
- 11) Dormer cheeks
- (12) Sarking
- (13) Roof felt
- 14) Trusses
- (15) Collar
- S Comman
- 16 Insulation
- 17 Parapet gutter
- (18) Eaves guttering
- (19) Rainwater downpipe
- (20) Verge boards /skews
- (21) Soffit boards
- (22) Partition wall
- 23 Lath / plaster
- 24) Chimney breast
- (25) Window pointing
- (26) Window sills
- (27) Rendering
- (28) Brickwork / pointing
- (29) Bay window projection
- (30) Lintels
- (31) Cavity walls / wall ties
- (32) Subfloor ventilator
- (33) Damp proof course
- 34) Base course
- 35 Foundations
- 36) Solum
- (37) Floor joists
- 38) Floorboards
- 39) Water tank
- Hot water tank
