Single Survey

Survey report on:

| Property Address | 50 Edgar Street Dunfermline Fife KY12 7EY |
| Prepared by | Jamie Biggar Harvey Donaldson & Gibson Chartered Surveyors |

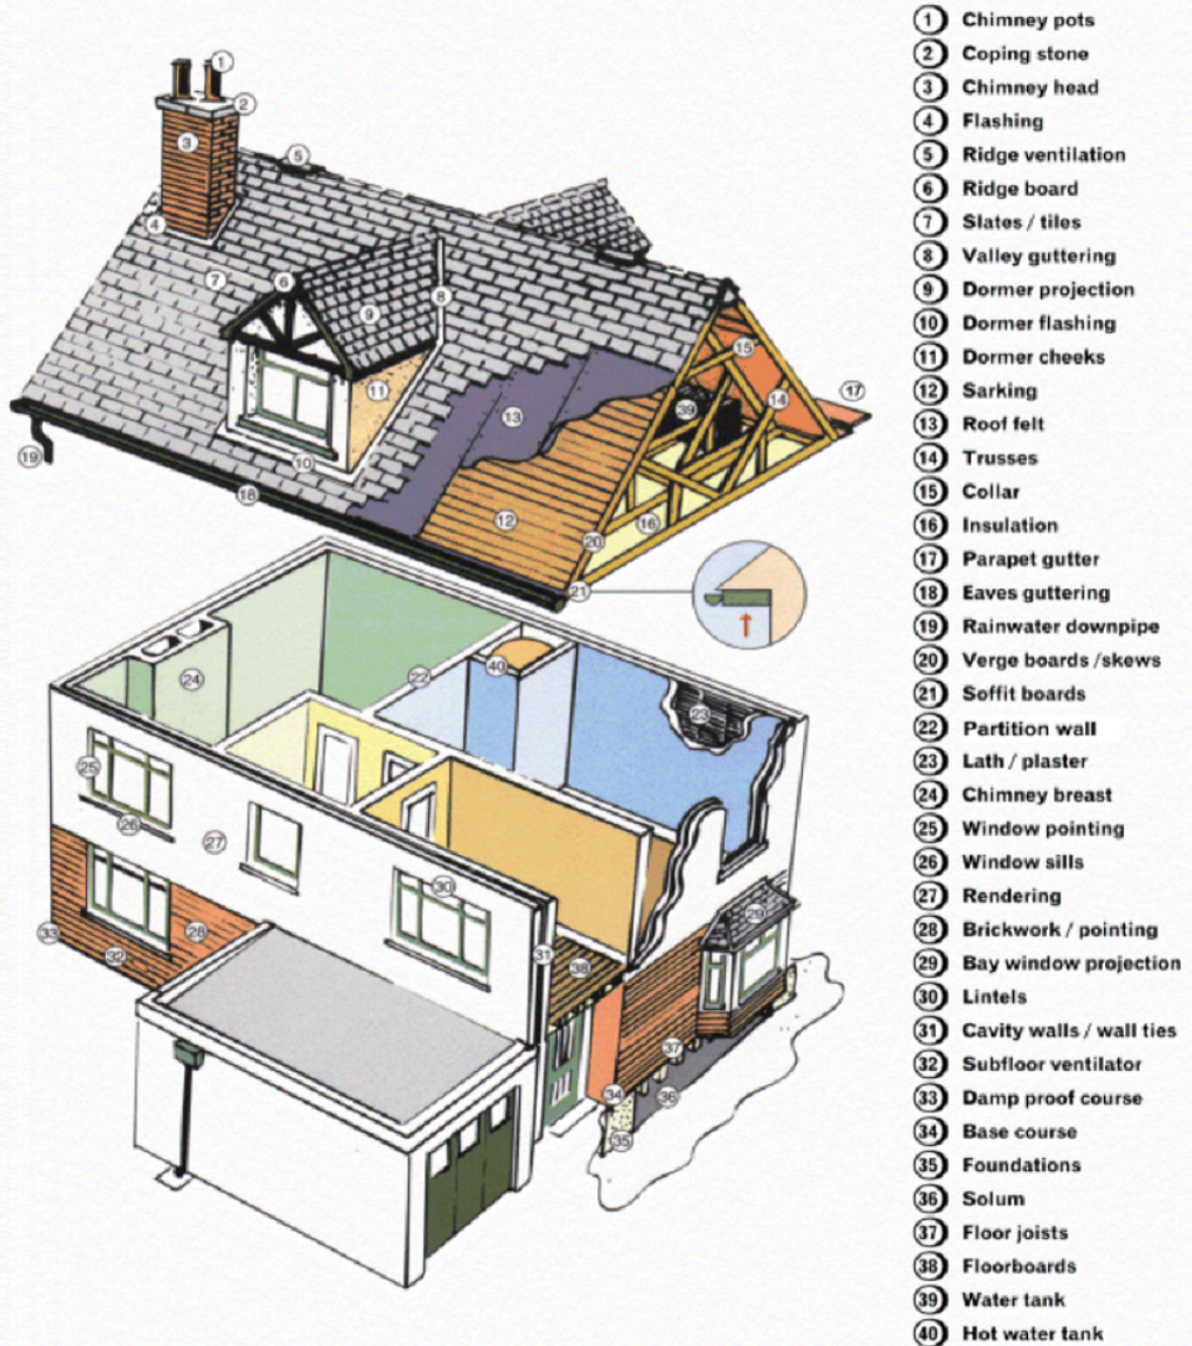
Sectional Diagram showing elements of a typical house

Reference may be made in this report to some or all of the above component parts of the property. This diagram may assist you in locating and understanding these items.
