Home Report

22 Maunsheugh Road
Fenwick KA3 6DN

Single Survey

Property Address	22 Maunsheugh Road Fenwick KA3 6DN
Customer	Loraine Wilkinson
Prepared by	Graham + Sibbald LLP
Date of Inspection	26/03/2025

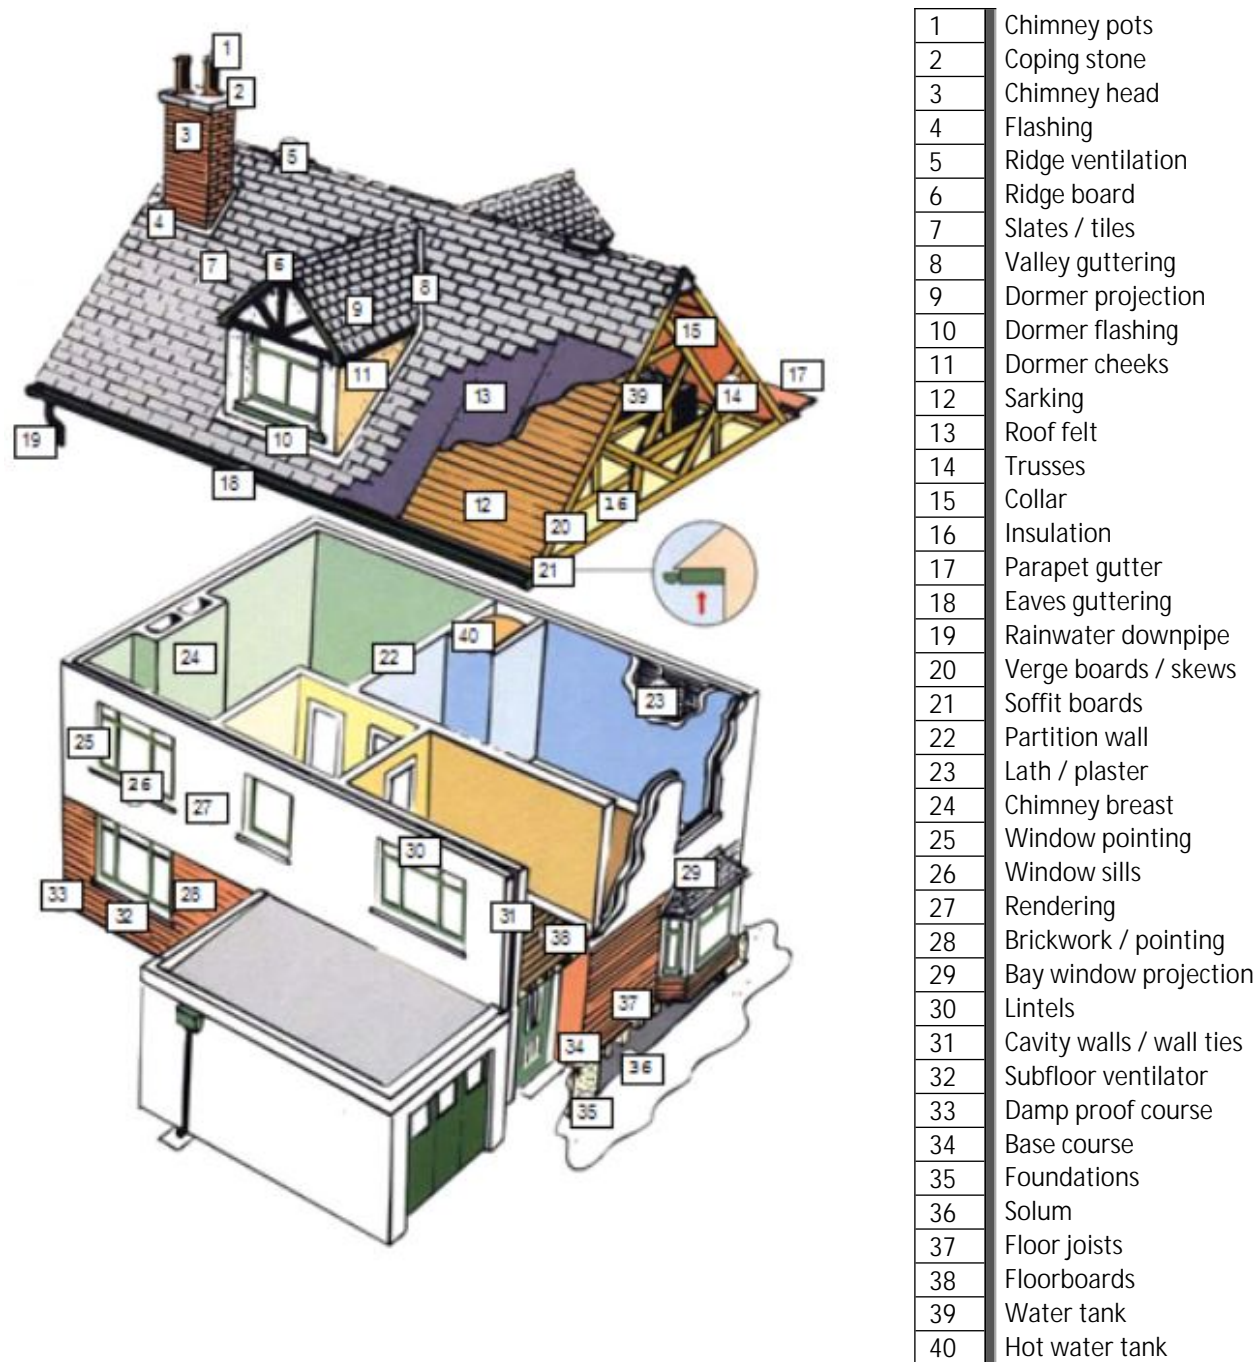
Sectional diagram showing elements of a typical house

Reference may be made in this report to some or all of the above component parts of the property. This diagram may assist you in locating and understanding these items.
