YOUR ONESURVEY
HOME REPORT

Flat 7
380 Easter Road
Edinburgh
EH6 8JW

SINGLE SURVEY

Single Survey

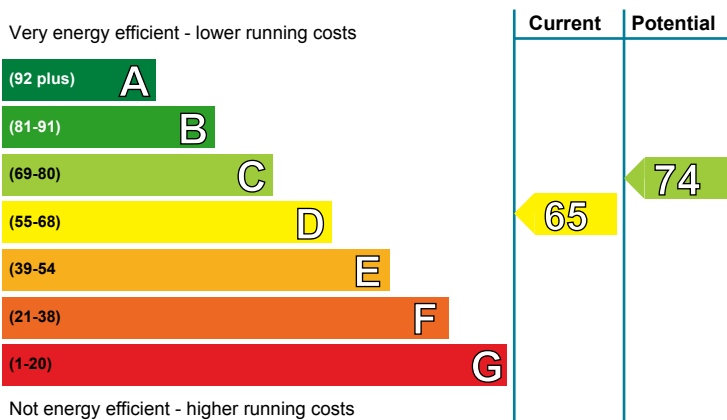
Energy Efficiency Rating

This graph shows the current efficiency of your home, taking into account both energy efficiency and fuel costs. The higher this rating, the lower your fuel bills are likely to be.

Your current rating is **band D (65)**. The average rating for EPCs in Scotland is **band D (61)**.

The potential rating shows the effect of undertaking all of the improvement measures listed within your recommendations report.
