Home Report

Single Survey

Property address	121 Brook Street Alva FK12 5AN
Customer	Jamie Robertson
Customer address	121 Brook Street Alva FK12 5AN
Prepared by	Shepherd Chartered Surveyors
Date of inspection	08/12/2025

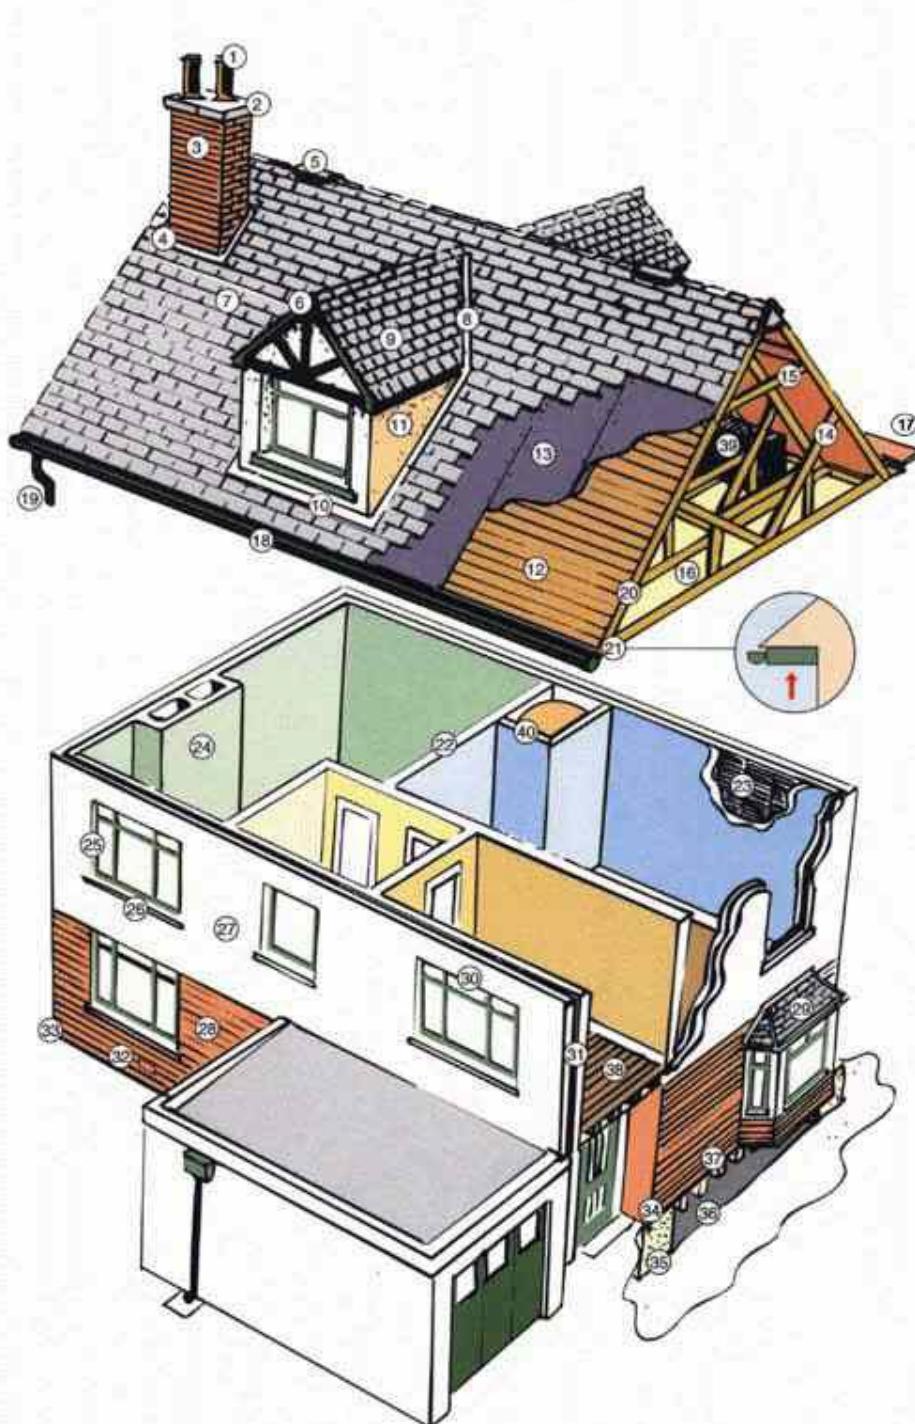
Sectional Diagram showing elements of a typical house

- 1 Chimney pots
- 2 Coping stone
- 3 Chimney head
- 4 Flashing
- 5 Ridge ventilation
- 6 Ridge board
- 7 Slates / tiles
- 8 Valley guttering
- 9 Dormer projection
- 10 Dormer flashing
- 11 Dormer cheeks
- 12 Sarking
- 13 Roof felt
- 14 Trusses
- 15 Collar
- 16 Insulation
- 17 Parapet gutter
- 18 Eaves guttering
- 19 Rainwater downpipe
- 20 Verge boards /skews
- 21 Soffit boards
- 22 Partition wall
- 23 Lath / plaster
- 24 Chimney breast
- 25 Window pointing
- 26 Window sills
- 27 Rendering
- 28 Brickwork / pointing
- 29 Bay window projection
- 30 Lintels
- 31 Cavity walls / wall ties
- 32 Subfloor ventilator
- 33 Damp proof course
- 34 Base course
- 35 Foundations
- 36 Solum
- 37 Floor joists
- 38 Floorboards
- 39 Water tank
- 40 Hot water tank

Reference may be made in this report to some or all of the above component parts of the property. This diagram may assist you in locating and understanding these items.

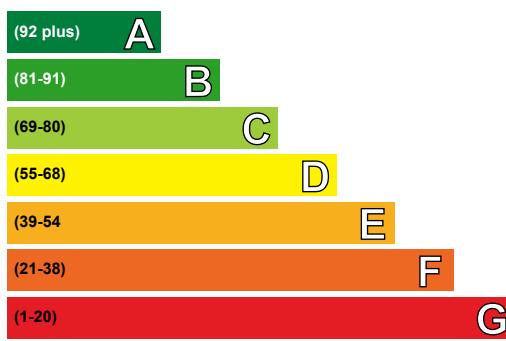
Energy Efficiency Rating

Very energy efficient - lower running costs

Not energy efficient - higher running costs

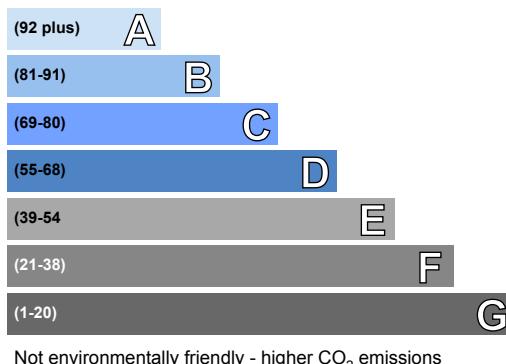
Environmental Impact (CO₂) Rating

Very environmentally friendly - lower CO₂ emissions
