13 Brewland Street,
Galston,
East Ayrshire,
KA4 8DP

Home Report

Single Survey

Property Address	13 Brewland Street, Galston, East Ayrshire, KA4 8DP
Reference	1439111
Customer Name	Suzanne Taylor
Date of Inspection	18th February 2026
Surveyor's name, qualifications and office	Kevin Masson BSc (Hons) MRICS DM Hall LLP Chartered Surveyors Eldo House, Monkton Road, Prestwick, KA9 2PB Tel: 01292 286974 email: ayrshireresidential@dmhall.co.uk
Prepared By	DM Hall LLP

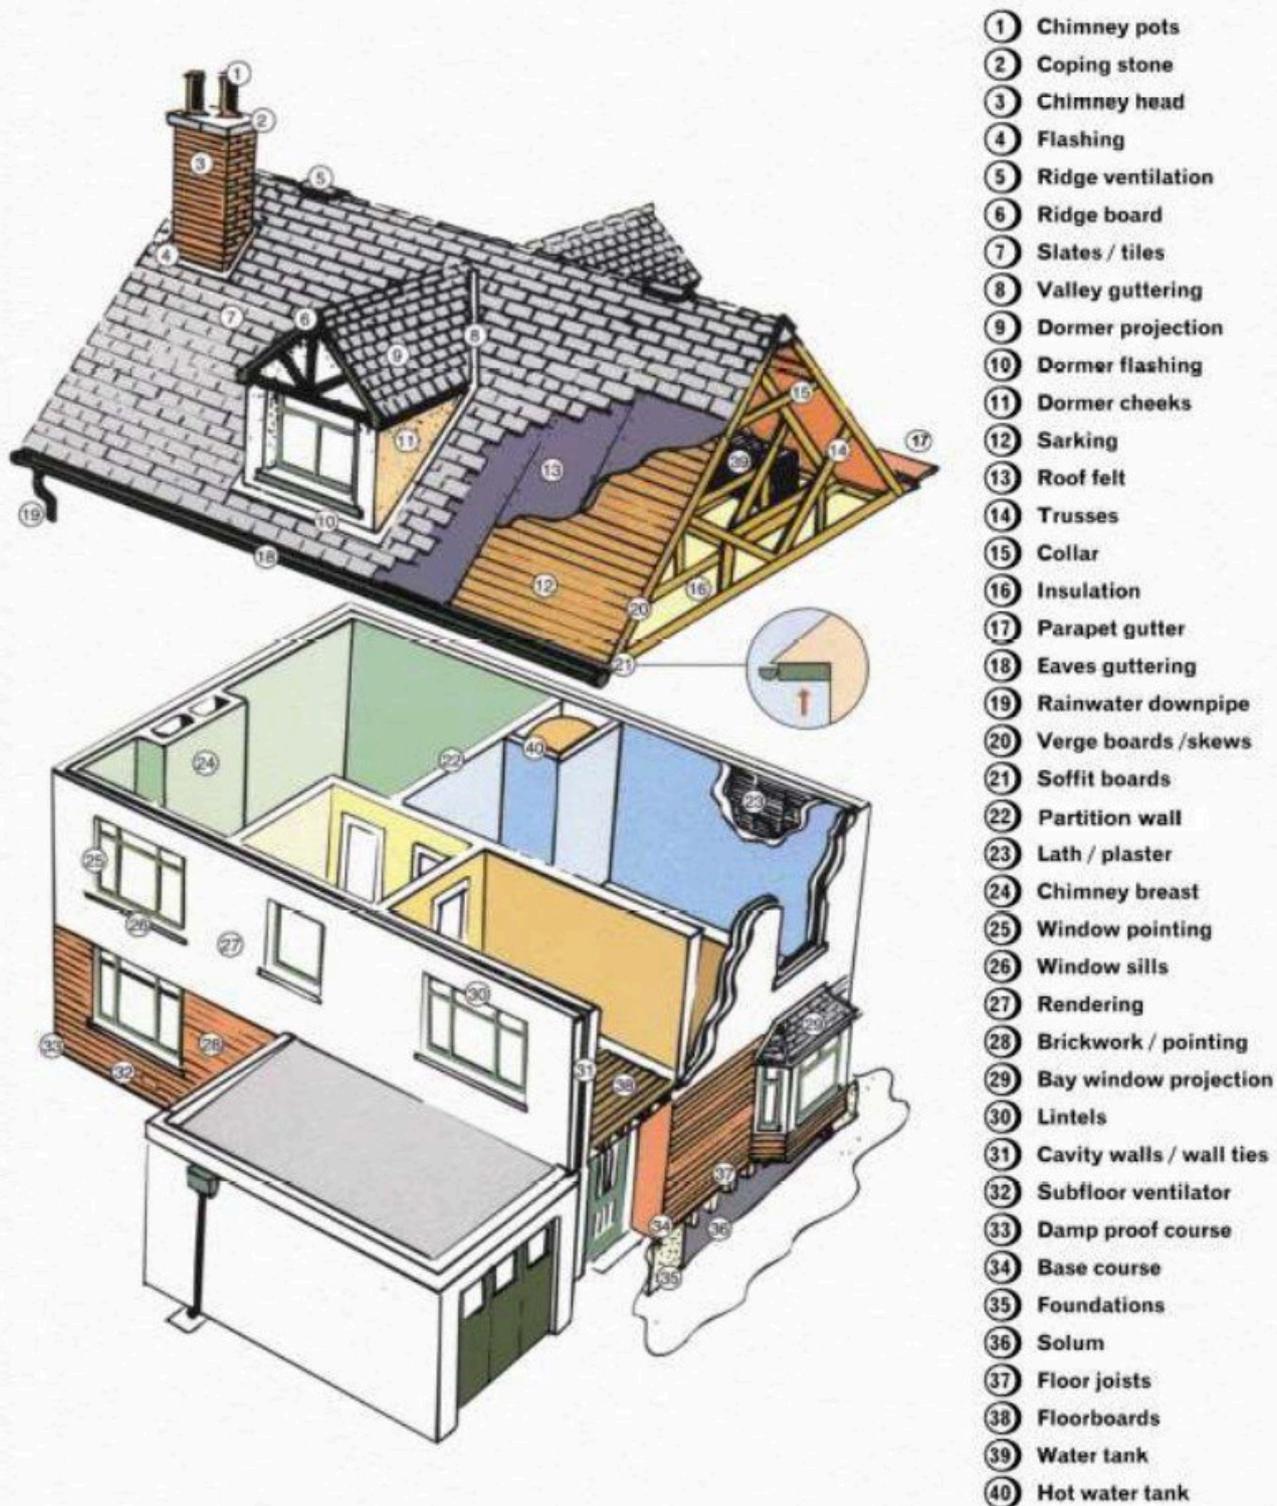
Sectional Diagram showing elements of a typical house

Reference may be made in this report to some or all of the above component parts of the property. This diagram may assist you in locating and understanding these items.
