Home Report

Single Survey

Survey Report on:

25c Main Street,
Ayr,
Ayrshire,
KA8 8BU

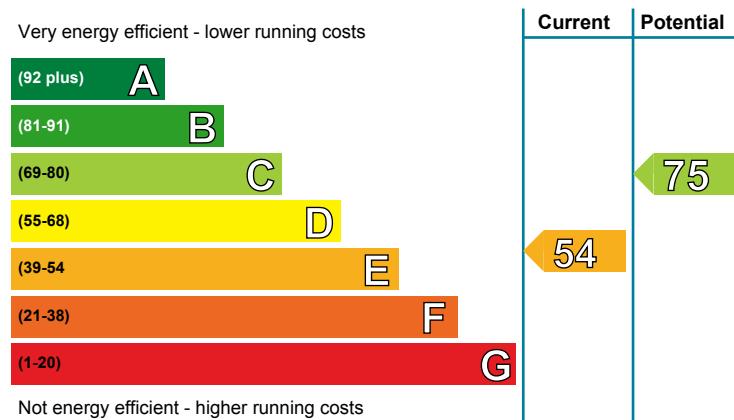
Energy Efficiency Rating

This graph shows the current efficiency of your home, taking into account both energy efficiency and fuel costs. The higher this rating, the lower your fuel bills are likely to be.

Your current rating is **band E (54)**. The average rating for EPCs in Scotland is **band D (61)**.

The potential rating shows the effect of undertaking all of the improvement measures listed within your recommendations report.
