Home Report

25 Clarinda Avenue,
Camelon,
FALKIRK,
FK1 4LZ

Single Survey

25 Clarinda Avenue,
Cameron,
FALKIRK,
FK1 4LZ

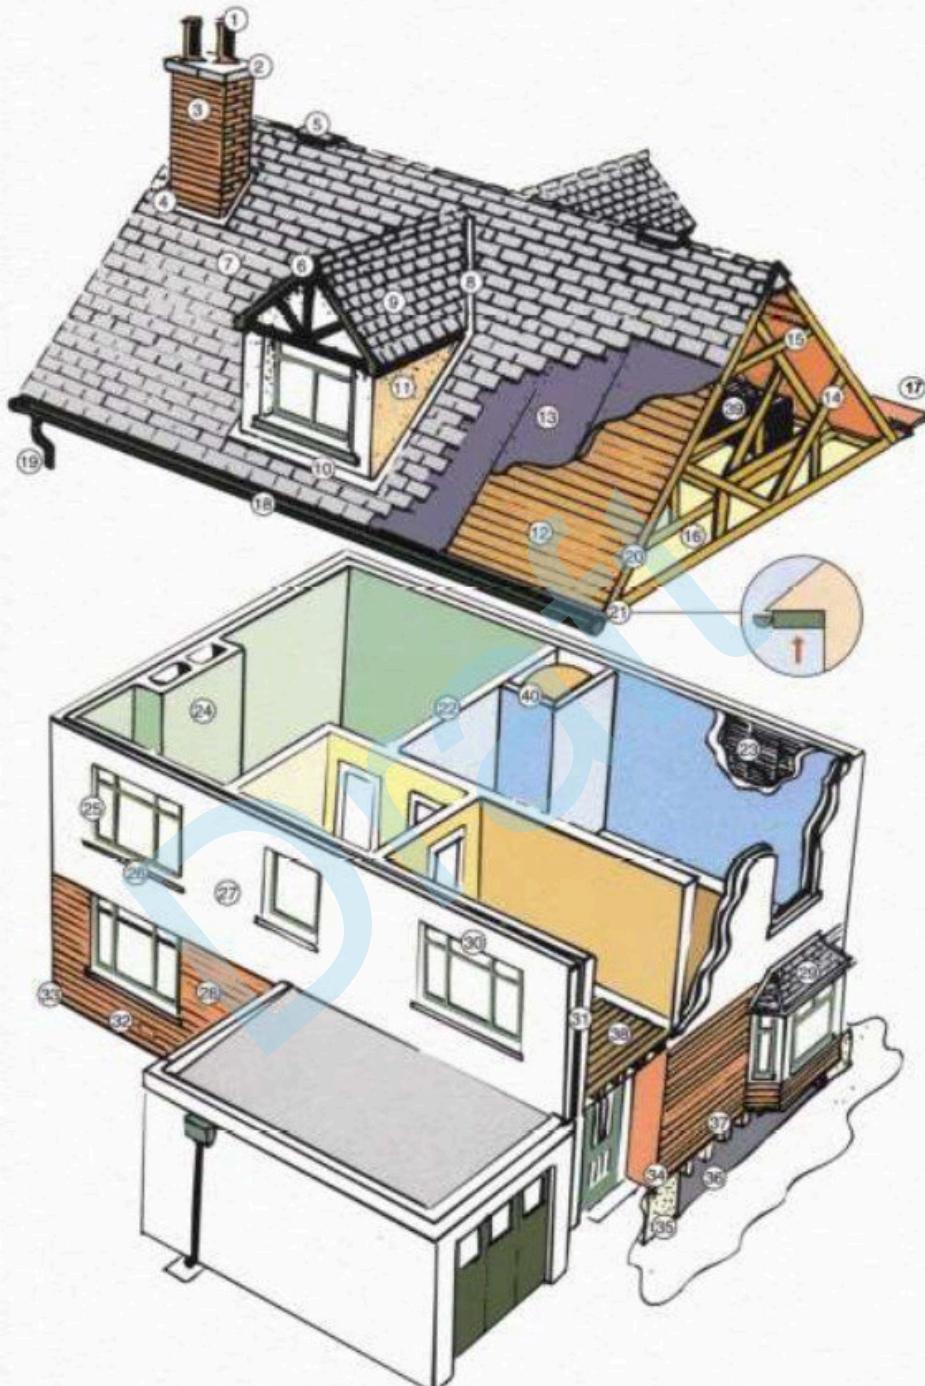
Sectional Diagram showing elements of a typical house

- 1 Chimney pots
- 2 Coping stone
- 3 Chimney head
- 4 Flashing
- 5 Ridge ventilation
- 6 Ridge board
- 7 Slates / tiles
- 8 Valley guttering
- 9 Dormer projection
- 10 Dormer flashing
- 11 Dormer cheeks
- 12 Sarking
- 13 Roof felt
- 14 Trusses
- 15 Collar
- 16 Insulation
- 17 Parapet gutter
- 18 Eaves guttering
- 19 Rainwater downpipe
- 20 Verge boards / skewers
- 21 Soffit boards
- 22 Partition wall
- 23 Lath / plaster
- 24 Chimney breast
- 25 Window pointing
- 26 Window sills
- 27 Rendering
- 28 Brickwork / pointing
- 29 Bay window projection
- 30 Lintels
- 31 Cavity walls / wall ties
- 32 Subfloor ventilator
- 33 Damp proof course
- 34 Base course
- 35 Foundations
- 36 Solum
- 37 Floor joists
- 38 Floorboards
- 39 Water tank
- 40 Hot water tank

Reference may be made in this report to some or all of the above component parts of the property. This diagram may assist you in locating and understanding these items.
