# Home Report

# Single Survey

<b>Property address</b>	Flat 1/1 41 Glebe Road Kilmarnock KA1 3DJ
<b>Customer</b>	Lucy Smith
<b>Customer address</b>	Flat 1/1 41 Glebe Road Kilmarnock KA1 3DJ
<b>Prepared by</b>	Shepherd Chartered Surveyors
<b>Date of inspection</b>	05/08/2024

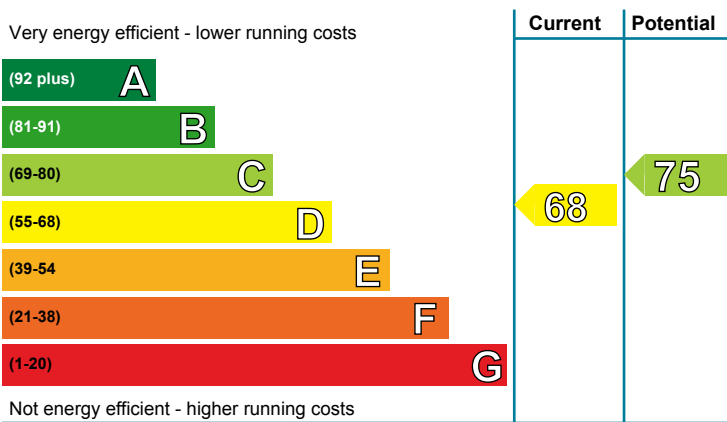
## Energy Efficiency Rating

This graph shows the current efficiency of your home, taking into account both energy efficiency and fuel costs. The higher this rating, the lower your fuel bills are likely to be.

Your current rating is **band D (68)**. The average rating for EPCs in Scotland is **band D (61)**.

The potential rating shows the effect of undertaking all of the improvement measures listed within your recommendations report.
