# Home Report

28 Walker Avenue, Troon, Ayrshire, KA10 6SA

# Single Survey

Property Address	28 Walker Avenue, Troon, Ayrshire, KA10 6SA
Reference	1272825
Customer Name	Donna Pepworth
Date of Inspection	14th October 2025
Surveyor's name, qualifications and office	Mark Rutherford MA (Hons) MRICS MA (Hons) MRICS  DM Hall LLP Chartered Surveyors Eldo House, Monkton Road, Prestwick, KA9 2PB  Tel: 01292 286974  email: ayrshireresidential@dmhall.co.uk

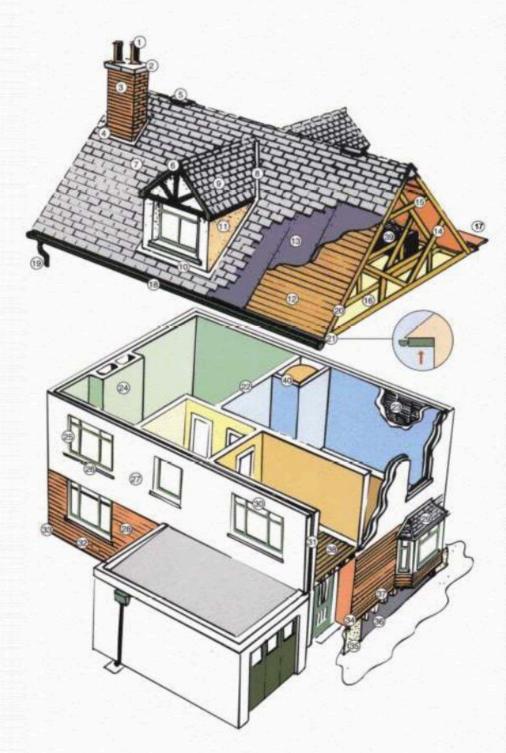
#### Sectional Diagram showing elements of a typical house

Reference may be made in this report to some or all of the above component parts of the property. This diagram may assist you in locating and understanding these items.

- (1) Chimney pots
- (2) Coping stone
- Chimney head
- (4) Flashing
- Ridge ventilation
- (6) Ridge board
- Slates / tiles
- (8) Valley guttering
- 9 Dormer projection
- (10) Dormer flashing
- (11) Dormer cheeks
- (12) Sarking
- (13) Roof felt
- (14) Trusses
- (15) Collar
- (16) Insulation
- (17) Parapet gutter
- (18) Eaves guttering
- (19) Rainwater downpipe
- (20) Verge boards /skews
- (21) Soffit boards
- (22) Partition wall
- (23) Lath / plaster
- Chimney breast
- (25) Window pointing
- (26) Window sills
- (27) Rendering
- Brickwork / pointing
- 29) Bay window projection
- Lintels
- (31) Cavity walls / wall ties
- Subfloor ventilator
- (33) Damp proof course
- Base course
- (35) Foundations
- (36) Solum
- (37) Floor joists
- Floorboards
- Water tank
- Hot water tank
